American Real Estate Inspection

SUMMARY REPORT

Client: Mr and Mrs Client
Realtor: Alan Brough,
Inspection Address: 1234 Favorite Street, Anywhere, CA 90000
Inspection Date: 3/26/2005 Start: 3:45 pm End: 6:00 pm
Inspected by: Steven L Dehlinger

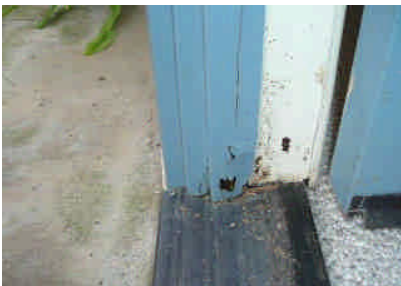
There is moisture type damage at the rear French door trim. Refer to pest report.

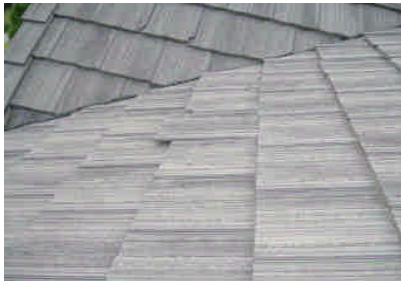
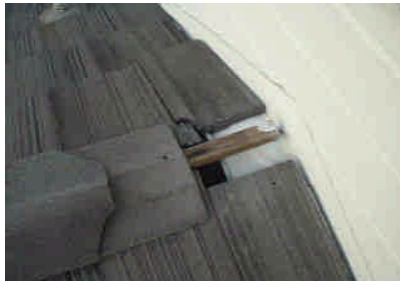
There are a number of cracked or broken tiles at various locations that should be serviced by a licensed C-39 Roofing Contractor

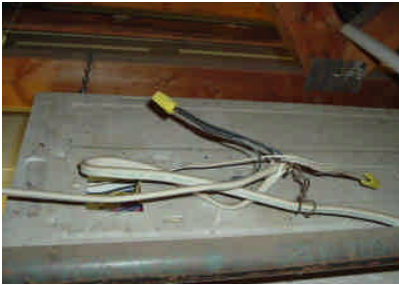
There are loose and uncovered wires and wire connections noted in the garage trusses. Recommend wiring be properly attached and enclosed.
