CONFIDENTIAL INSPECTION REPORT

12345 Any Street, Anywhere, CA

9/6/2005 10:00 am to 1:00 pm

SUMMARY REPORT

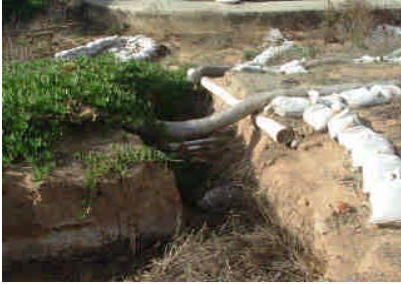
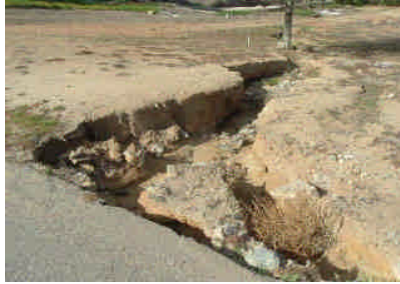
There is some deep erosion noted at the front and west side that appears to be road water runoff.

Recommend evaluation by a drainage contractor to divert or contain the runoff to prevent further erosion.

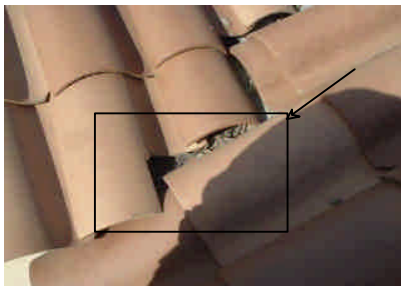
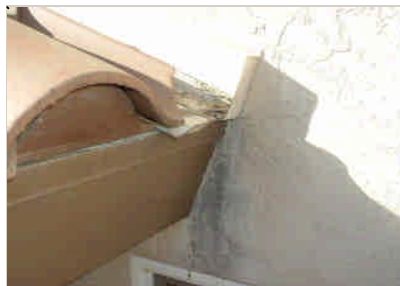
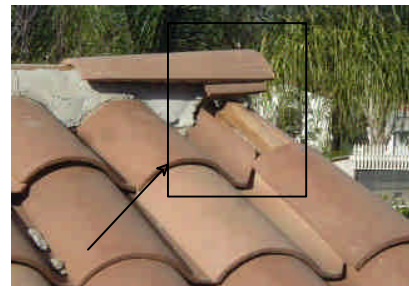
The roof needs to be evaluated/serviced by a Licensed C39 roofing contractor for the following reasons: There are a number of slipped, cracked, and detached tiles at various locations. There is debris in some of the roof flashings and the edge/corner flashing by the air conditioner is not properly angled to divert slow moving water off the roof without dripping down the wall. There is an exposed wood piece over the kitchen dining room area, and a missing bird stop outside the family room sliding door. This service should be scheduled well before the close of escrow, because additional defects could be revealed by a specialist, and our service does not include any guarantee against leaks. For a guarantee, a roofing company would have to perform a water-test and issue a roof certification.

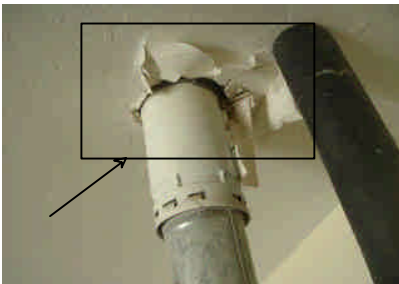
There is a moisture stain on the ceiling at the water heater vent pipe, and the pipe is touching the drywall. this is a one inch clearance requirement and there should be a proper drywall can installed. You should ask the roofer to look at this pipe where it passes through he roof.

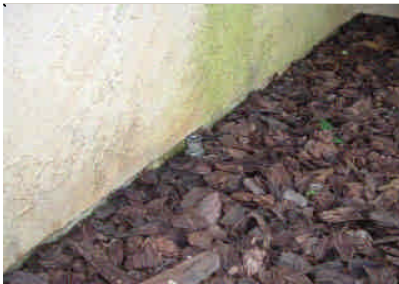
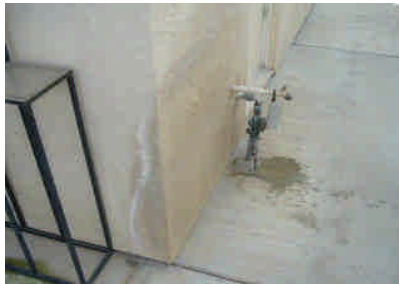
We do not evaluate sprinkler systems, but some sprinklers appear to be hitting the structure. Recommend re-directing sprinklers.

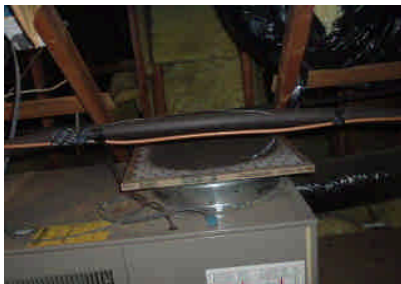
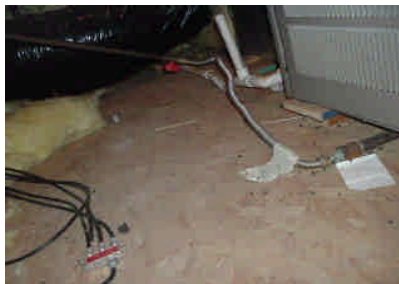
The furnace and air handler in the attic are not secured and is sitting on OBS panels. Recommend unit be properly secured By a Licensed C20 HVAC Contractor to prevent movement during seismic activity and to evaluate and confirm proper base spacing.

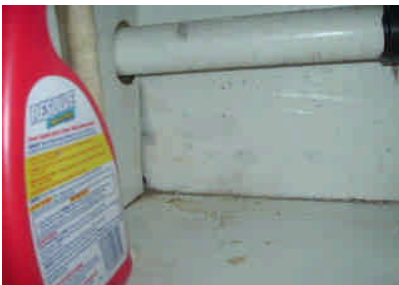
There is active leakage and dark stains under the kitchen sink. Recommend evaluation by a licensed C20 Plumbing Contractor or drainage contractor to determine cause of moisture or to repair any leakage. Dark staining could indicate microbial type growth.. (See Moisture concern notations near the end of this report)

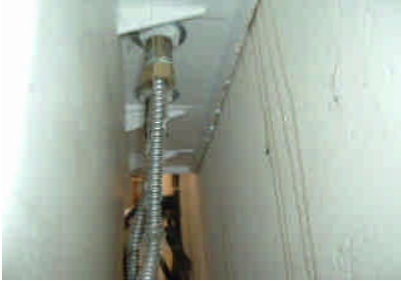
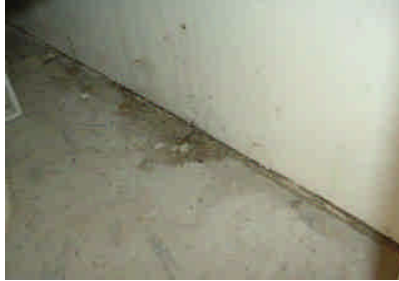
The laundry sink is functional, but there is evidence of seepage behind the splash plate. We routinely recommend that you consider adding a sealed waterproof backing board behind the sink to help prevent water from splashing behind the sink and on to the wall.
